UNDERWATER BRIDGE INSPECTION REPORT

STRUCTURE NO. 73551

SAUK RIVER

DISTRICT 3 - STEARNS COUNTY

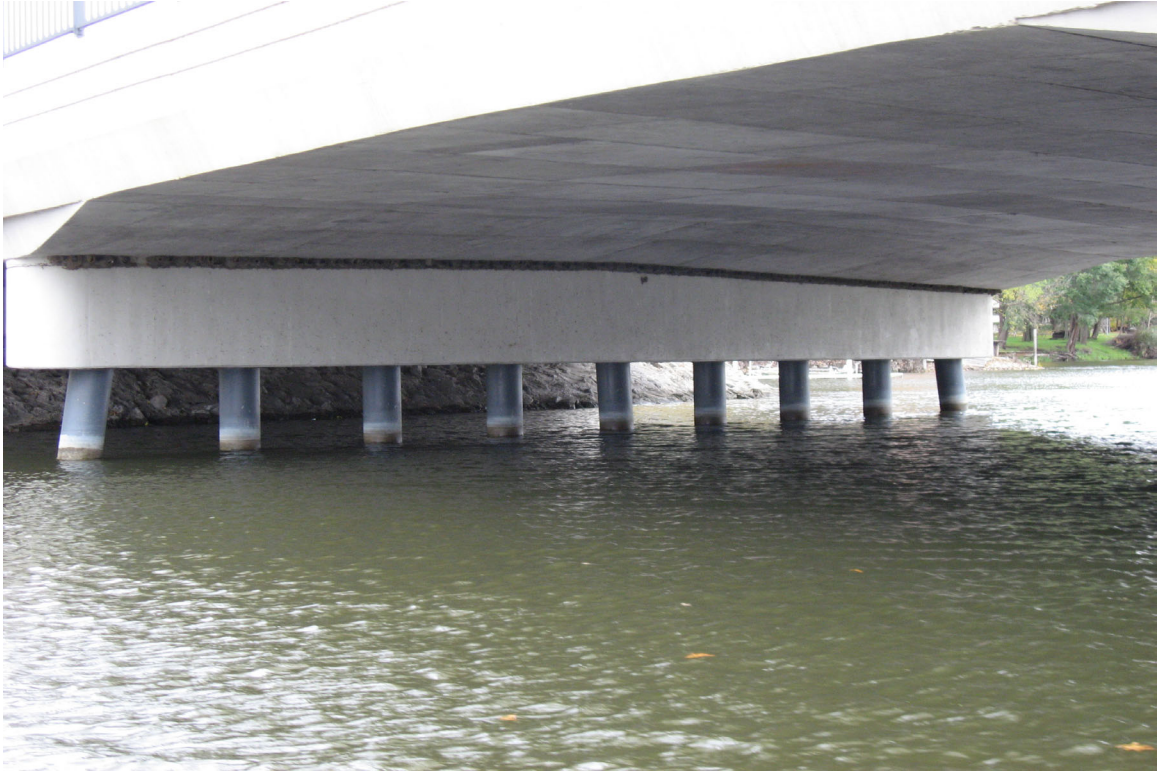
Photograph 1. View of Pier 1, Looking Northeast.

- (A) All of the piles for Piers 1 through 4 exhibited coating loss from 1 foot above the waterline to the channel bottom with light aquatic growth below the waterline. Minor surface corrosion with small rust nodules 1/8 inch in diameter was observed below water on less than 10 percent of the surface area with no related section loss. There was minimal overall deterioration present on the piles in the regions of the coating loss.

- (A) Reinspect the submerged substructure units at the normal maximum recommended (NBIS) interval of five (5) years.

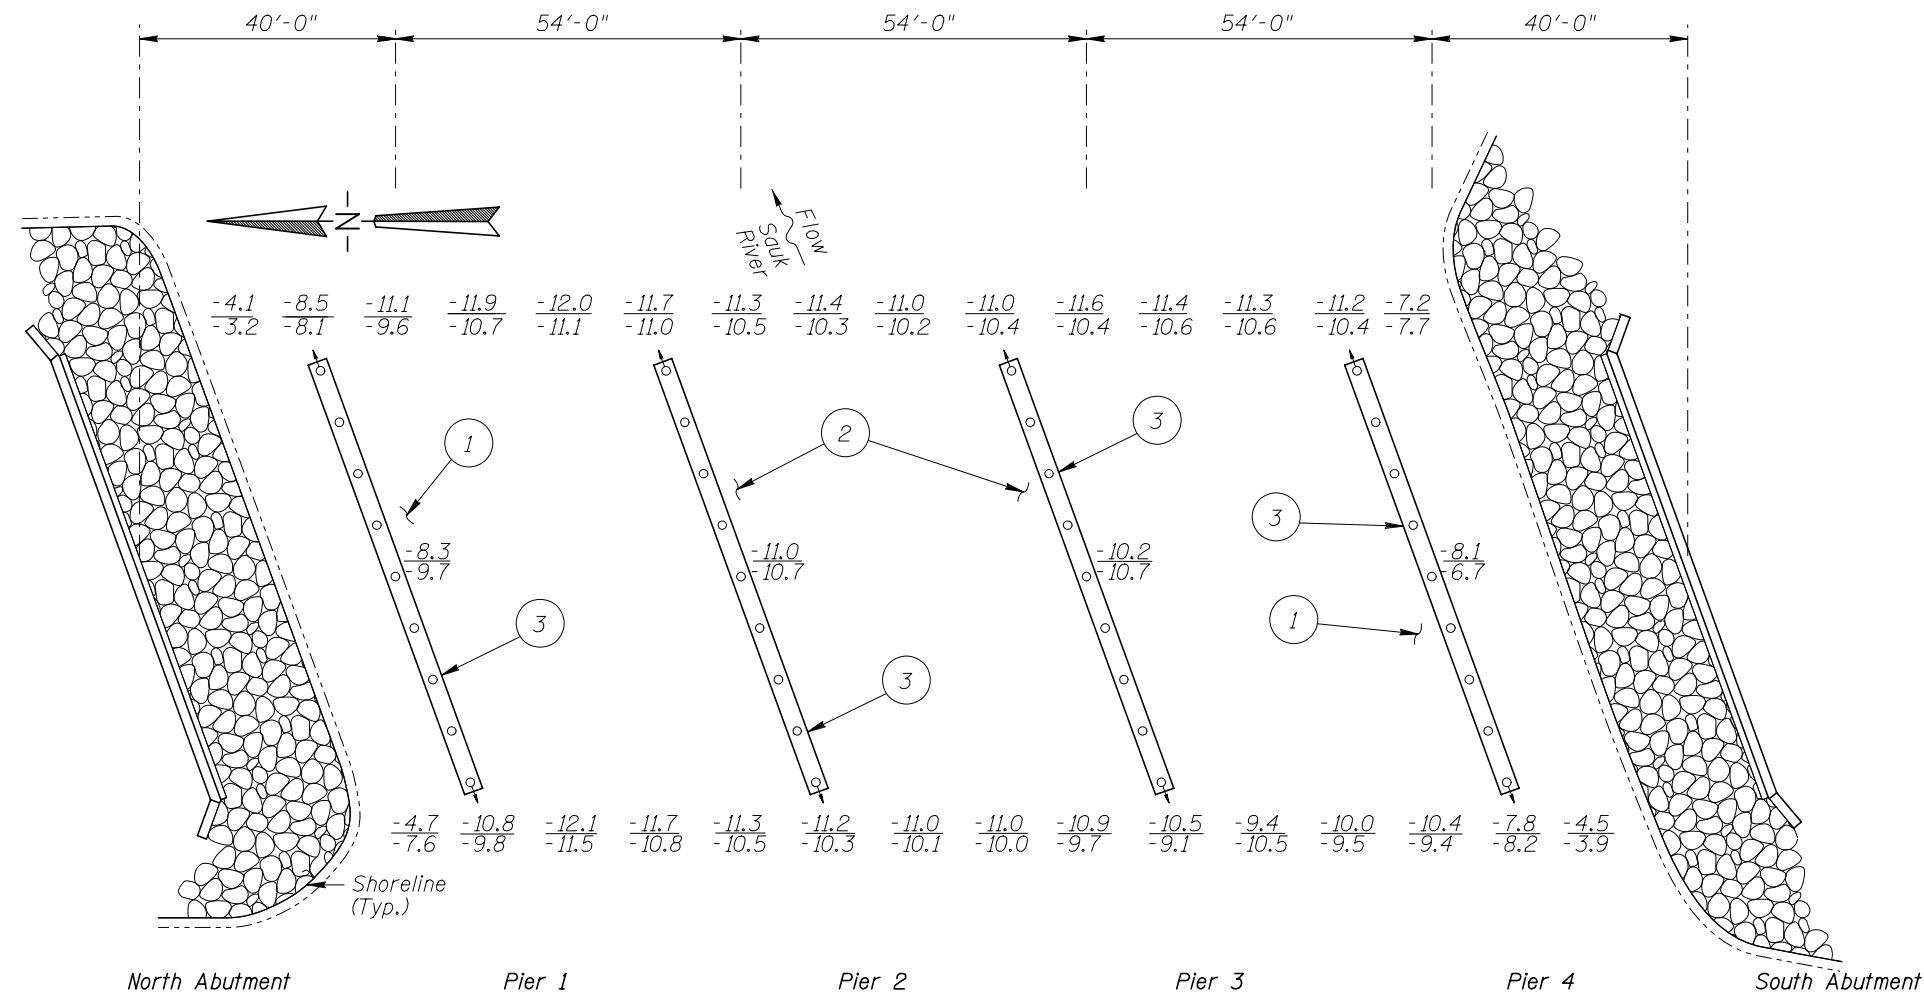
INSPECTION AND SOUNDING PLAN

- The channel bottom material around Piers 1 and 4 consisted of up to 1 foot diameter riprap and sand.
- The channel bottom material around Piers 2 and 3 consisted sand and some stones with up to 4 inches of probe rod penetration.
- All of the piles for Piers 1 through 4 exhibited coating loss from 1 foot above the waterline to the channel bottom with minimal overall steel deterioration and with light aquatic growth on the surfaces below the waterline. Minor surface corrosion with small rust nodules, 1/8 inch in diameter, were observed below water on less than 10 percent of surface area with no related section loss.
